**Limited Inspection for Asbestos Containing Materials
Greenville County Square
301 University Ridge
Greenville, S.C. 29601**

August 30, 2012

Environmental Testing and Management, Inc.

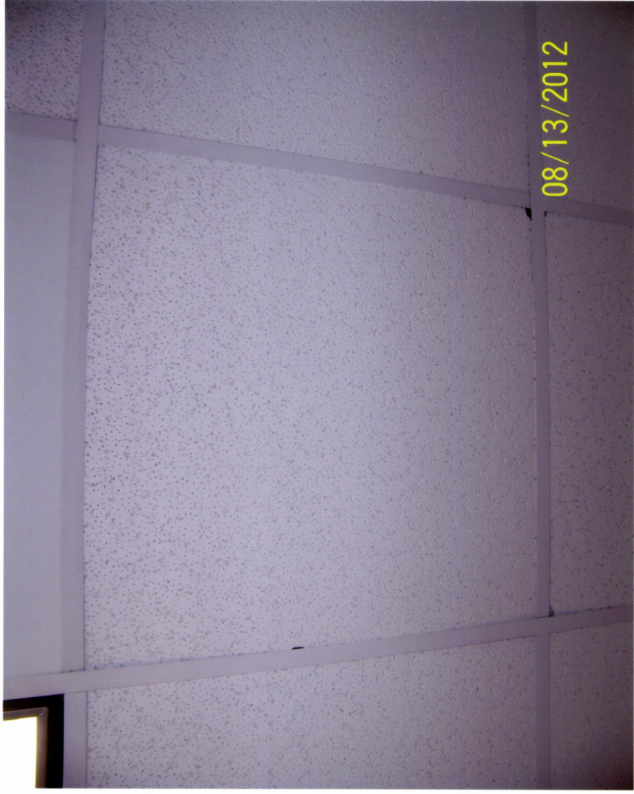
Photo #2

The inspection began in the lobby to the County Council area, which is just adjacent the security station. Samples (1-3) were collected of the ceiling tile style present in this area (Armstrong 770, see photo #2). These returned as negative for the presence of asbestos. Above these ceiling tiles, there is un-insulated metal deck and fiberglass pipe insulation. White mastic is present on the main trunk lines. This mastic is similar in appearance to the white mastic sampled previously (see report dated July 16, 2012 entitled "Limited Inspection for Asbestos Containing Materials - Selected Areas - Greenville County Square) and found to be non-asbestos containing.

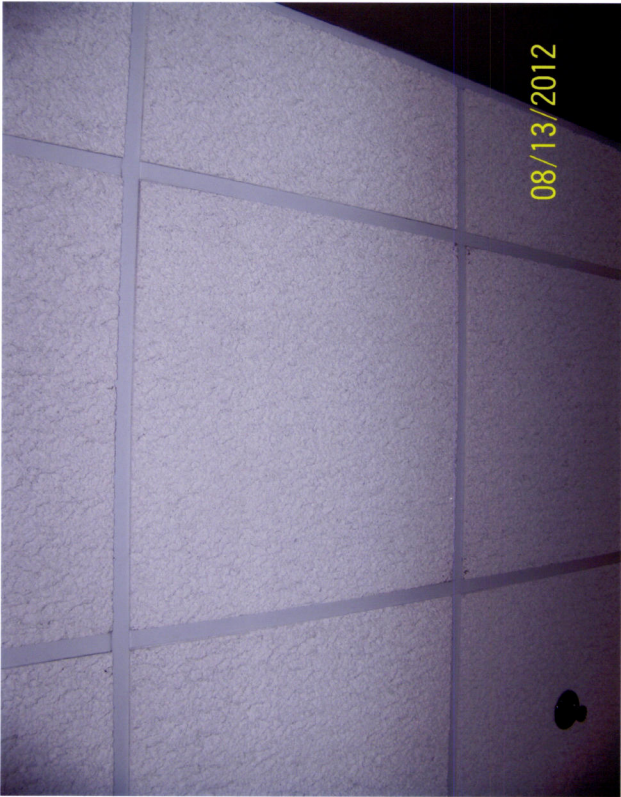
Photo #1

Proceeding to the assembly room for County Council meetings, carpet is present here as well but appears to be over ceramic tile in some areas. In the hallway behind Council chambers, the same white mastic as noted above is on the HVAC ductwork. A different

type of ceiling tile is present here (see photo #1) and so three samples (7-9) were collected of this tile. Results returned as negative.

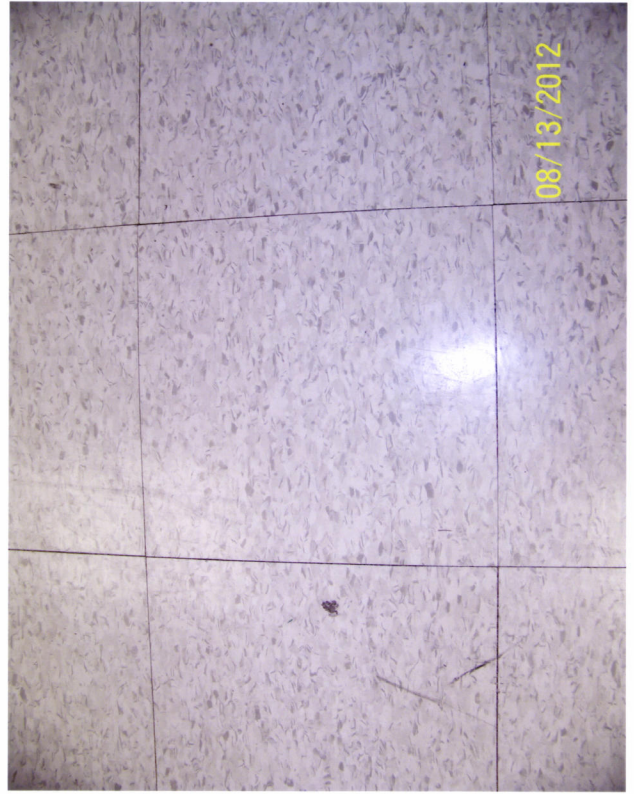
Photo #4

In Voter Registration, there is a storage area where the floor tile has been removed and remaining black mastic can be visually observed (photo #3). This mastic should be treated as an asbestos containing material. In the adjacent room, there is 12" floor tile (photo #4) with the same black mastic underneath. In the bathroom, there is 9" floor tile and mastic which is presumed to be positive. Across the hallway there are some additional bathrooms, but no new suspect materials are present in them (ceramic floor tile, sheetrock walls with ceramic tile present on the lower half, and sheetrock ceiling).

Certain materials (the grey 12" floor tile in Voter Registration, the various floor tiles present in the canteen) were not tested at this time in order to preserve the continuity of the flooring. Once a renovation is scheduled for these areas, the floor tile and mastic can be tested to determine whether or not they are asbestos containing materials.

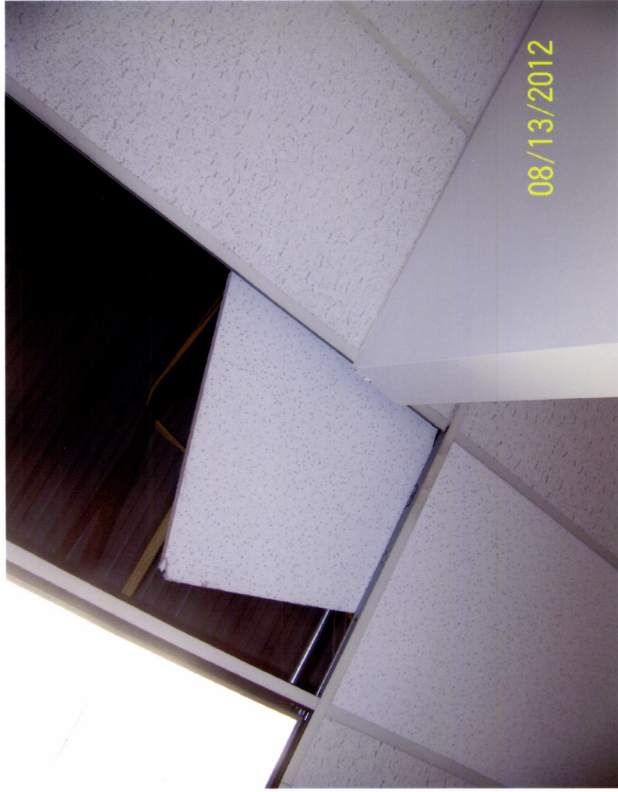
Photo #6

Suite 4000 (Probation & Parole) has the original high ceilings, which have two different types of ceiling tile present. Above the ceiling tiles, there is fiberglass insulated HVAC duct, un-insulated metal decking and metal roof joists. No mastic was visible from our vantage point. Three samples (21-23; see photo #6 and 24-26; see photo #7) were collected of each type of ceiling tile. All results returned as negative.

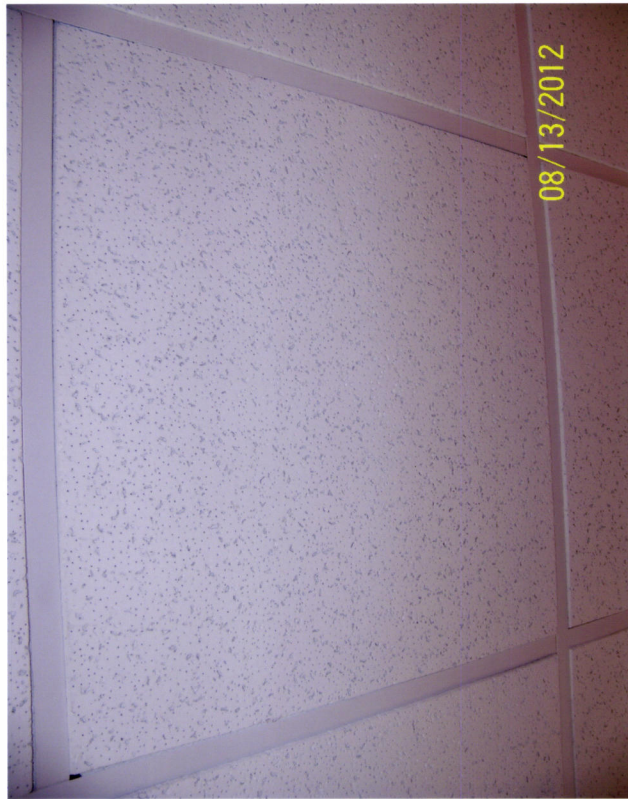
Photo #5

In Conference Room D there is a different type of ceiling tile (Armstrong 704A). Three samples (13-15) were collected of this ceiling tile (see photo #5), which returned as negative for the presence of asbestos.

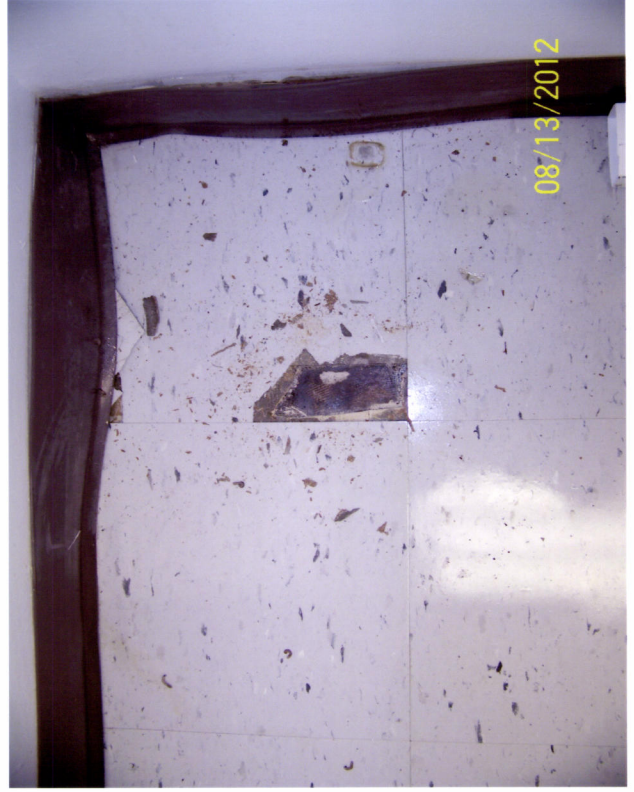
Photo #8

In the back of this Suite, there is a conference/break room and two layers of floor tile and mastic are present. The top layer is a 12" grey tile and the bottom layer is a beige floor tile of indeterminate size. Samples (27-30) were collected of the top layer of floor tile and mastic (see photo #8), while samples (31-33) were collected of the bottom layer. The top layer was found to be negative upon bulk analysis, but the bottom layer of both floor tile and mastic were found to be positive. Since the floor tile and mastic will all be removed at the time of renovation as a unit, all layers will be abated and disposed of as asbestos containing material. This bottom layer of tile appears to extend beyond the conference/break room into the carpeted hallway up to about the second office on the left.

Materials found to definitively test positive for the presence of asbestos include the mixed (black and yellow) mastic present under carpeting, as well as the floor tile and mastic found in Suite 4000 (Probation & Parole) in the conference/break room and extending somewhat out into the hallway underneath the carpeting.
