**Limited Inspection for Asbestos Containing Materials
Greenville County Family Courthouse
301 University Ridge
Greenville, S.C. 29601**

September 18, 2012

Environmental Testing and Management, Inc.

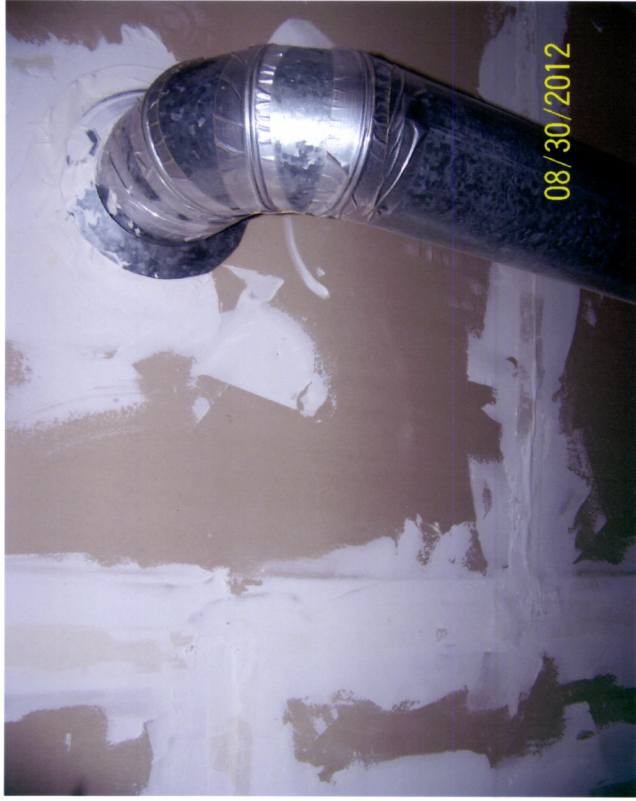
Photo #1

The inspection began in the original portion of the building, in the hallway behind the courtrooms. Three samples (1-3) were collected of the predominant ceiling tile present in this area (see photo #3). These samples returned as negative for the presence of asbestos. Three samples (4-6) were also collected of sheetrock and joint compound (see photos # 1 and 2). These samples returned as negative as well.

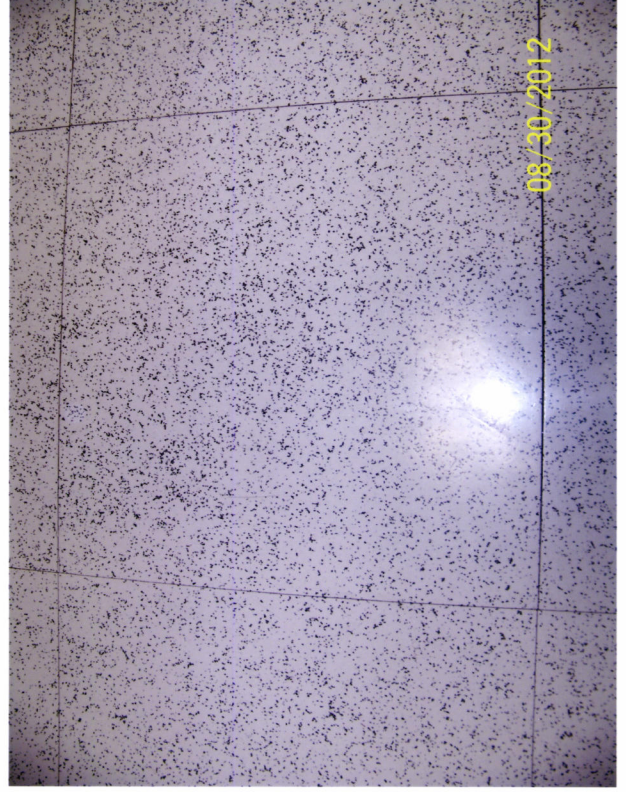
Photo #4

Much of the floor area behind the courtrooms is covered with carpet squares. However, there are several areas of floor tile. In a small coffee room, three samples (7-9) were collected of the ivory and black mottled floor tile and its associated tan mastic (see photo #4). Three samples (10-12) were also collected of the light grey cove base and its associated mastic. All of these samples returned as negative upon bulk analysis. In accordance with SCDHEC regulations for non-friable organically bound (NOB) materials, a sample of each item was subsequently submitted for TEM analysis. All materials were confirmed to be negative for the presence of asbestos.

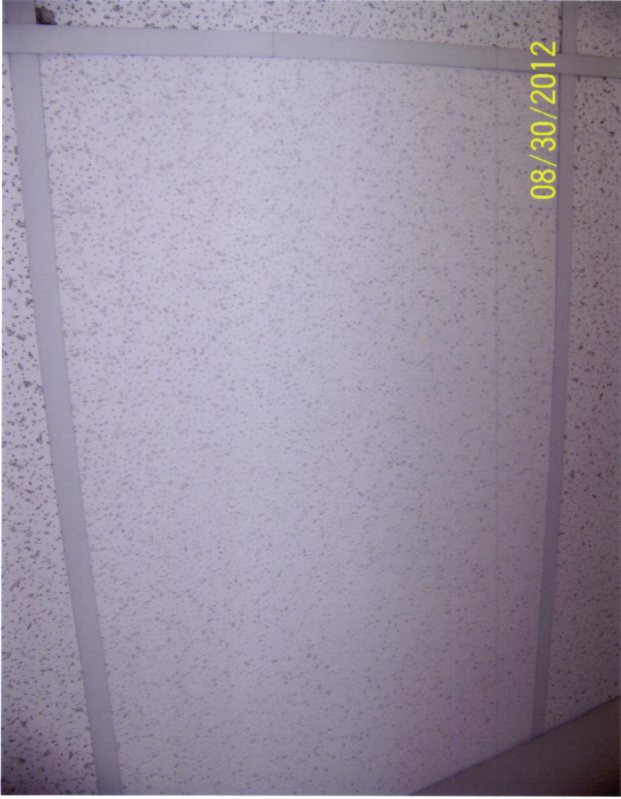
Photo #5

Also in the coffee room, three samples (13-15) were collected of the replacement style of ceiling tile (see photo #5). Two additional samples (16-17) were collected of sheetrock and joint compound. All samples returned as negative.

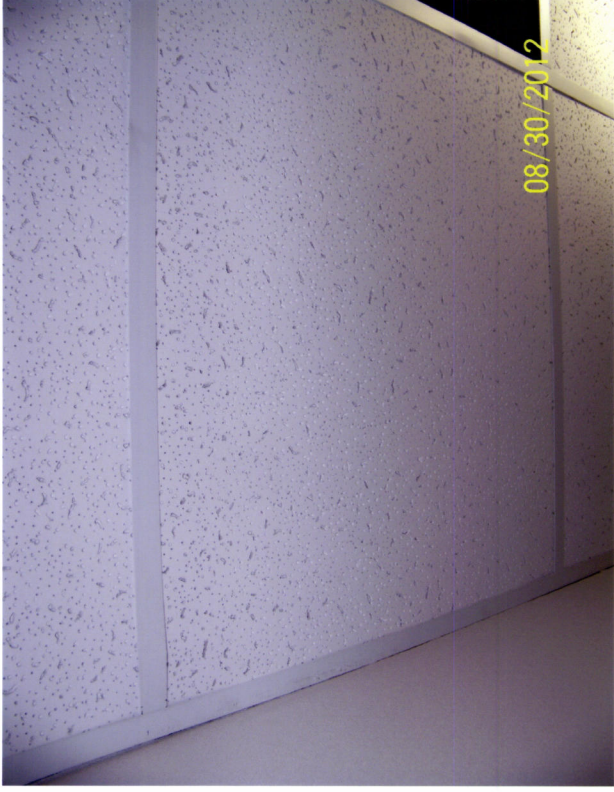
Photo #6

In the hallway just in front of Courtroom 4, three samples (24-26) were collected of the ceiling tile found in this area (see photo #6). Two additional samples (27-28) were collected of the sheetrock and joint compound. All samples returned as negative.

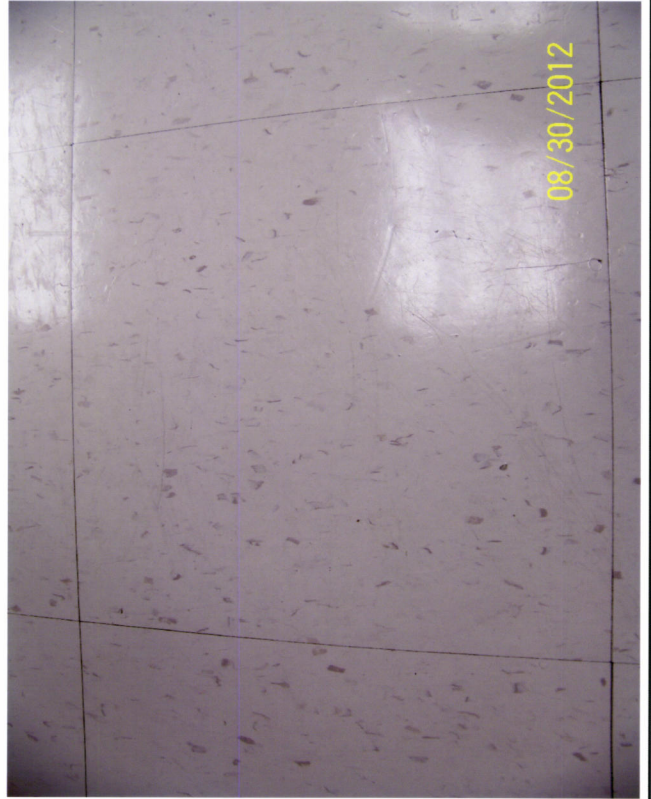
Photo #7

In the large break room (room 1000), three samples (35-37) were collected of the white flecked floor tile present here (see photos # 7 and 8) and its associated tan mastic. This is the top layer of floor tile in this room and it was found to be negative as confirmed by TEM analysis (the tan mastic is the same as that associated with samples 7-9). The bottom layer appears to be the same as the floor tile as is present in the break room as represented by samples 7-9 (also negative). This white flecked floor tile is present in several areas throughout the original portion of the Family Court.
